**Flood Control Project Maintenance
Levee Inspections**

Maintenance Issue Types Only, Levee Inspection Report By Mile - Fall 2016

Reclamation District No. 0817 Carlin

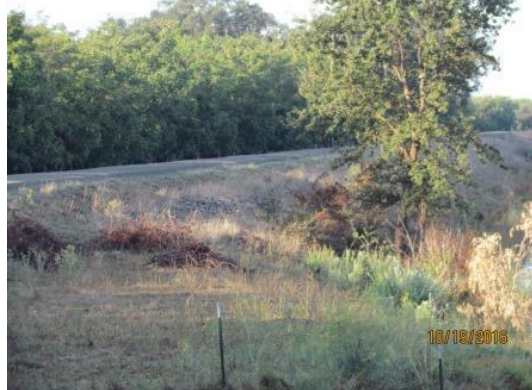
Photo 1 of 1 : FA_2016_RD0817_12_27_20161025_00018.jpg

| Well maintained vegetation, Fall 2016. | | | | | |

View of well maintained vegetation on the waterside looking downstream. Fall 2016.

| V1 : Control annual grass and weeds on the levee slopes and easements. | | | | | |

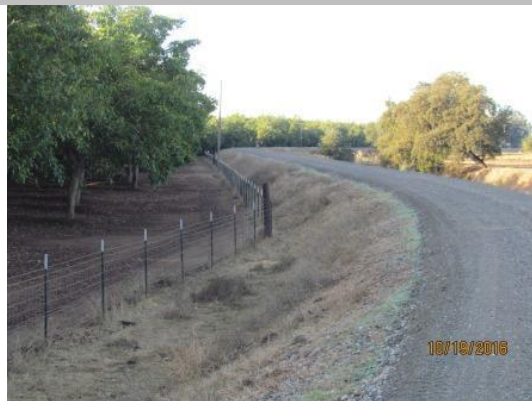
Photo 1 of 1 : FA_2016_RD0817_12_26_20161025_00019.jpg

| Well maintained vegetation, Fall 2016. | | | | | |

View of well maintained vegetation on the landside looking downstream.
Fall 2016.

| V1 : Control annual grass and weeds on the levee slopes and easements. | | | | | |

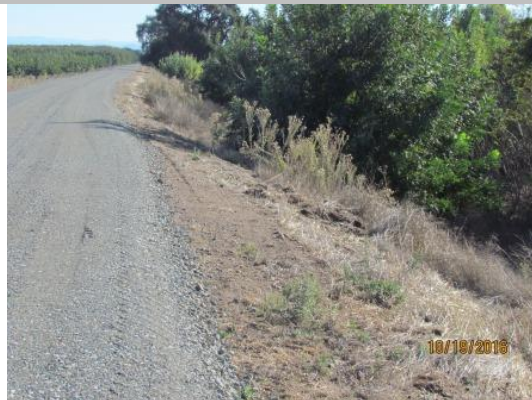
Photo 1 of 1 : FA_2016_RD0817_13_14_20161025_00020.jpg

| Annual grass needs to be maintained, Fall 2016. | | | | | |

View of annual grass that needs to be maintained on the waterside looking upstream, Fall 2016.

| V1 : Control annual grass and weeds on the levee slopes and easements. | | | | | |

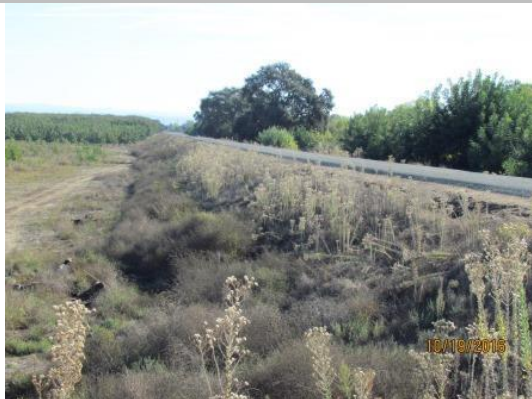
Photo 1 of 1 : FA_2016_RD0817_13_13_20161025_00018.jpg

| Annual grass needs to be maintained, Fall 2016. | | | | | |

View of annual grass that needs to be maintained on the landside looking upstream, Fall 2016.

| V1 : Control annual grass and weeds on the levee slopes and easements. | | | | | |

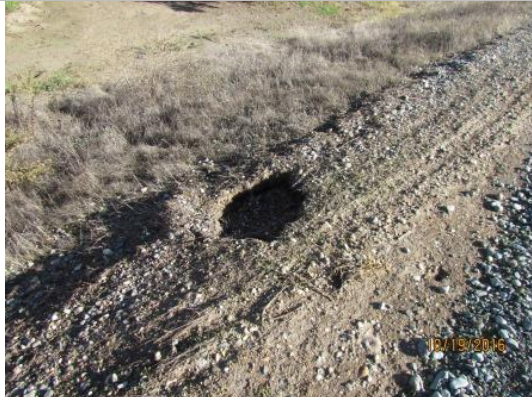
Photo 1 of 1 : FA_2016_RD0817_13_15_20161025_00021.jpg

| Sink hole were old stump was needs to be backfilled and compacted. Fall 2016. | | | | | |

View of a sink hole were old stump was. This needs to be backfilled and compacted. Fall 2016.

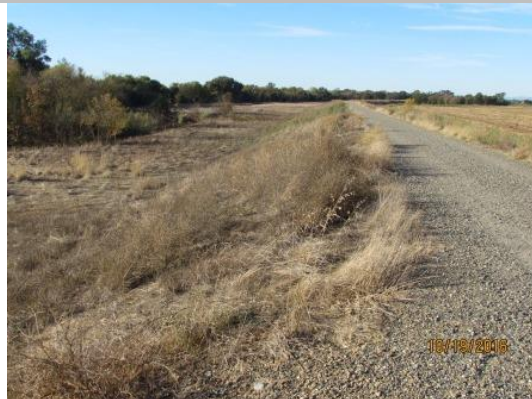
Photo 1 of 1 : FA_2016_RD0817_14_17_20161025_00029.jpg

| Annual grasses need to be maintained. Fall 2016. | | | | | |

View of annual grasses that need to be maintained on the waterside looking downstream. Fall 2016.

| V1 : Control annual grass and weeds on the levee slopes and easements. | | | | | |

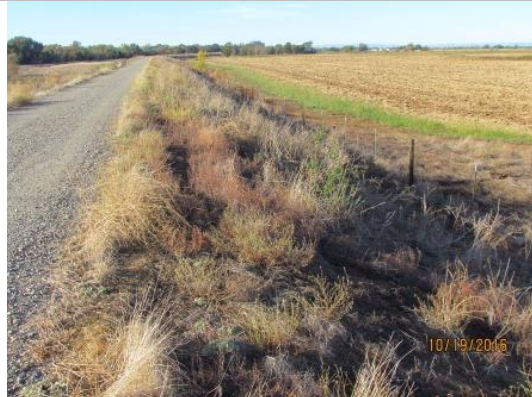
Photo 1 of 1 : FA_2016_RD0817_14_16_20161025_00028.jpg

| Annual grasses need to be maintained. Fall 2016. | | | | | |

View of annual grasses that need to be maintained on the landside looking downstream. Fall 2016.

| V1 : Control annual grass and weeds on the levee slopes and easements. | | | | | |

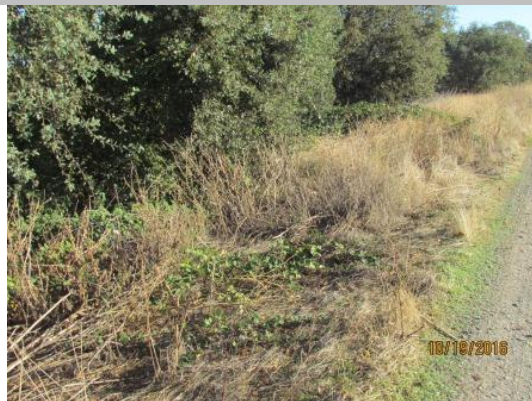
Photo 1 of 1 : FA_2016_RD0817_14_8_20161025_00036.jpg

| Dense berry bushes along slope. Fall 2016. | | | | | |

View of blackberry bushes that have taken over the landside slope looking upstream. Fall 2016.

| V2 : Remove the wild growth other than native grasses from the levee slopes. | | | | | |
